FOCUS *CR* & *CR*e**

HAND TILT ADJUSTMENT GUIDE

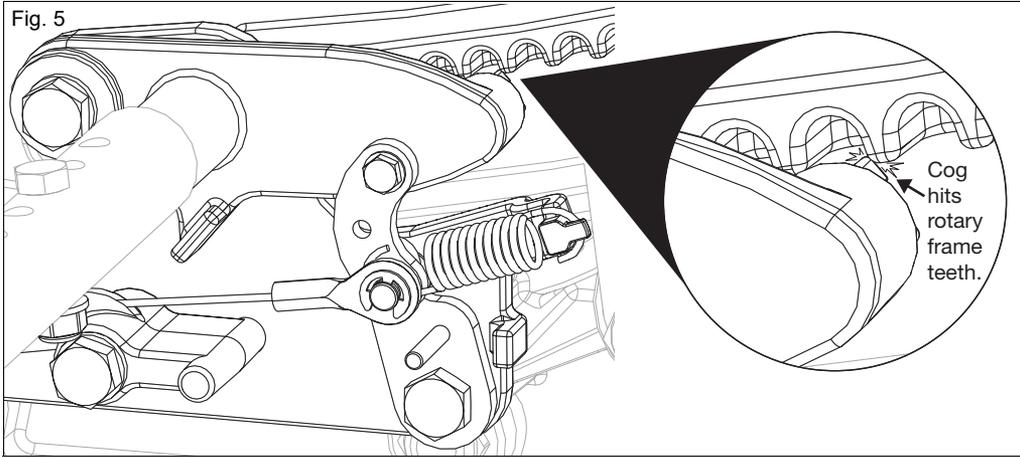
Fig. 5

1. Clicking Noise

A clicking noise is heard during the action of tilting the chair. This is caused by the cog hitting the rotary frame teeth as the chair tilts. Clicking is caused by the cable being too loose or the trigger(s) not being engaged fully. This may occur on one or both sides.

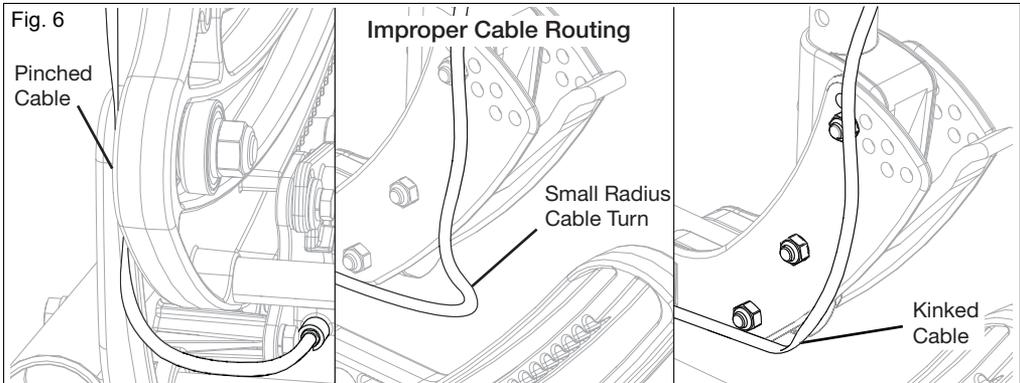
Fig. 6

There are different points on the chair where the tilt cable may become pinched, kinked or have too tight of turns (small radius cable turn) which causes friction.

Correct any pinch points, tight turns (small radius cable turn) or kinks. Proper cable routing will help prevent cable issues. Before correcting any cable issues, always check the condition of the cable and replace if damaged.

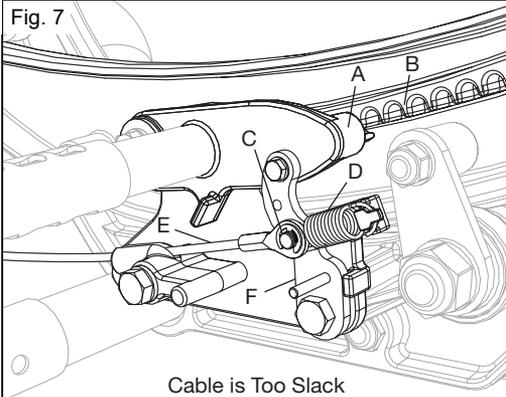
Fig. 7

Cable is Too Slack

When cable adjuster is too short, cable (E) is too long, the tilt mechanism is not fully actuated at the pivot point (C). The spring (D) is not overcome and the linkage (F) does not pull the cog (A) down and out of the rotary frame teeth (B).

Loosen the jam nut (A). Hold the top portion of cable adjustment hardware and turn the adjuster (B) clockwise to remove slack and counterclockwise to increase slack. The trigger should move no more than 1/8" before pulling the cable (F) and linkage (C and H). The lower linkage (H) should also rest against the tilt stop (I) with the cog (D) engaged in the rotary frame teeth (E). Test the levers after each adjustment to ensure levers engage properly and tilt mechanism releases and locks. Tighten jam nut.

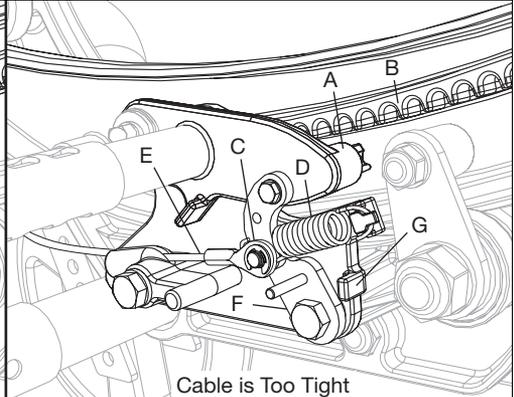
Cable is Too Tight

When cable adjuster is too long, cable (E) is too tight, the tilt mechanism does not fully lock and the linkage (F) does not rest against the tilt stop (G). This prevents the cog (A) from fully engaging into the rotary frame teeth (B).

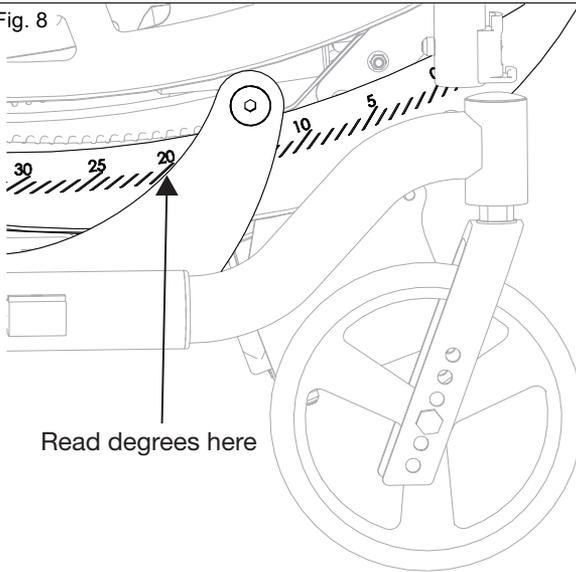
Fig. 8

Improper COG settings will result in a reading that falls outside the acceptable range and will cause difficulty in initiating tilt. Lock wheel locks (if equipped). Place occupant in chair with all equipment that attaches to upper frame, such as foot boxes, backpacks, etc. Squeeze triggers or depress foot pedal and allow rotary frame to find its resting place. The tilt angle degree reading should be between 17° and 23°.

- Remove the seat frame position locking screws (Fig. 17:B) using a 5mm Allen wrench.
- If resting angle is larger than 23°, pull seat frame toward the front of the chair until approximate 20° resting angle is achieved. If frame rests at an angle smaller than 17°, push seat frame toward the rear until approximate 20° is achieved.
- Different occupants will respond differently, but a good starting point is to move the seat frame ½" for every 5° that the angle is off from 20°.
- Once optimum position is achieved, reinstall and tighten positioning screws in holes closest to optimum position. Screws may be placed in front or rear hole of seat frame saddle (Fig. 17:A).
